NCC erects eight semi-detached hillside houses in Bollstanäs, Upplands Väsby, Stockholm.

## INSTALLATIONS

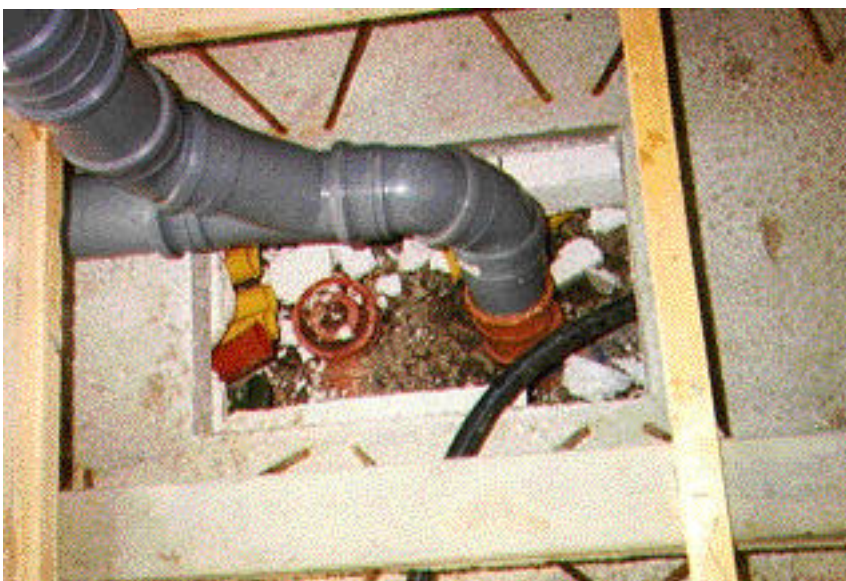
Common throughout for waste pipe and exhaust air down into the ground through the bottom structural floor concrete plate.

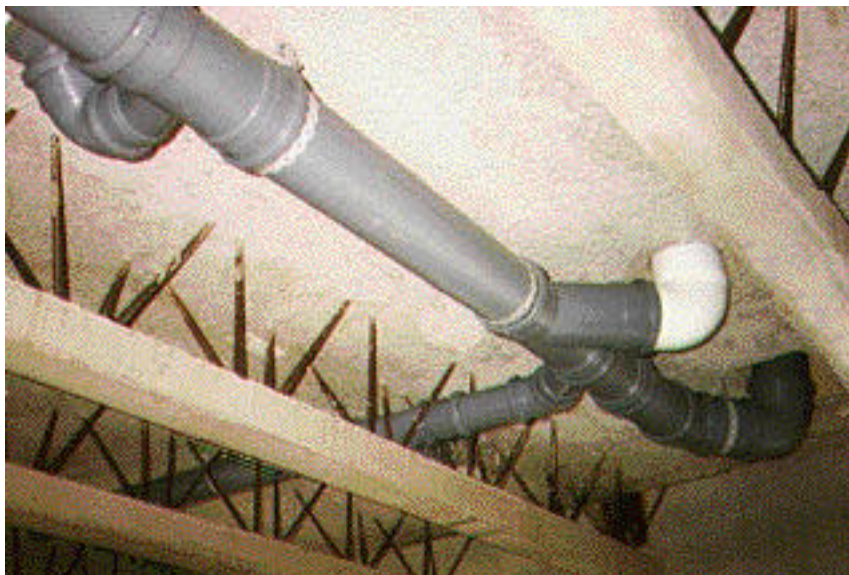
Sewage pipes from bath and toilet at upper floor is invisibly installed inside the structural upper floor.

Easily accessible in the future.

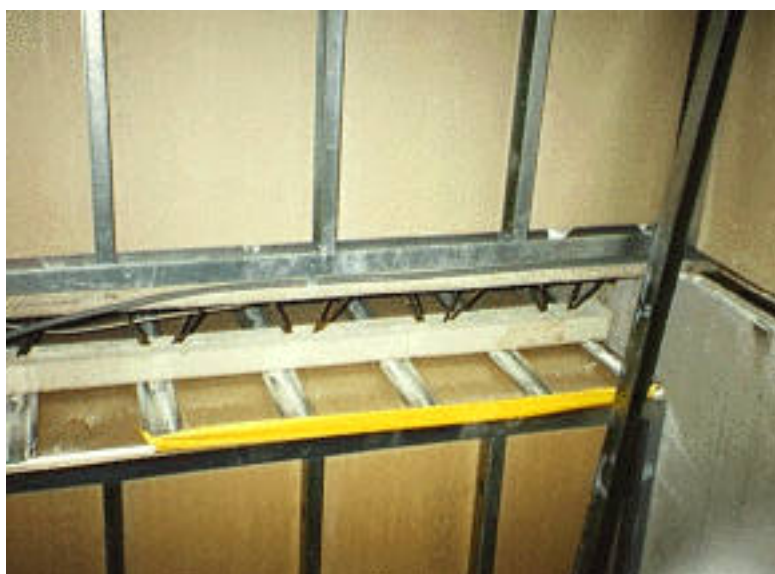
The picture is taken at the stairwell and shows the interior walls with one side boarding.

The ceiling on steel studs can be seen below the Resaro structural floor.

Electrical cables for stair lighting.  
(A steel stud stands leaning against the corner)

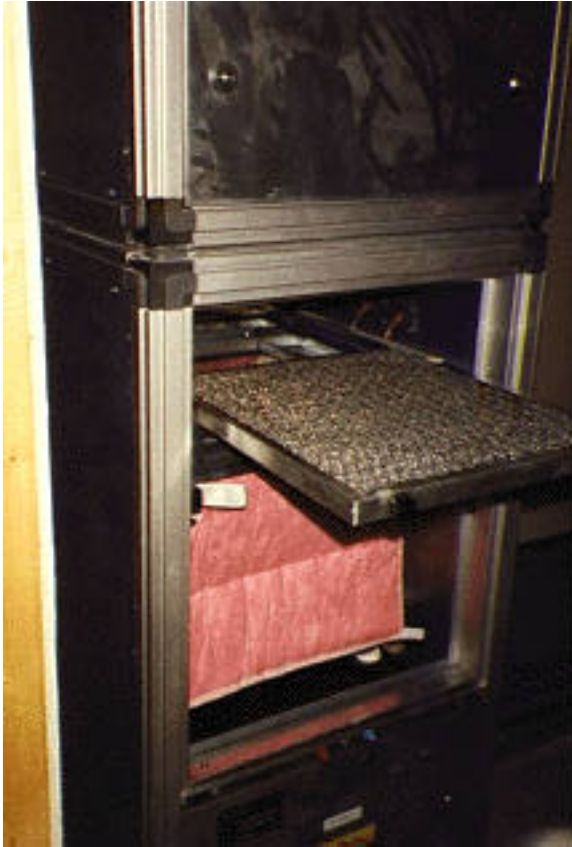
### Rough filter.

All circulation air together with the ventilation air passes two filters before it enters the living rooms.

The rough filter is simply cleaned about two times a year by giving it a shower in the bathtub.

A pressure guard tells you when it is time.

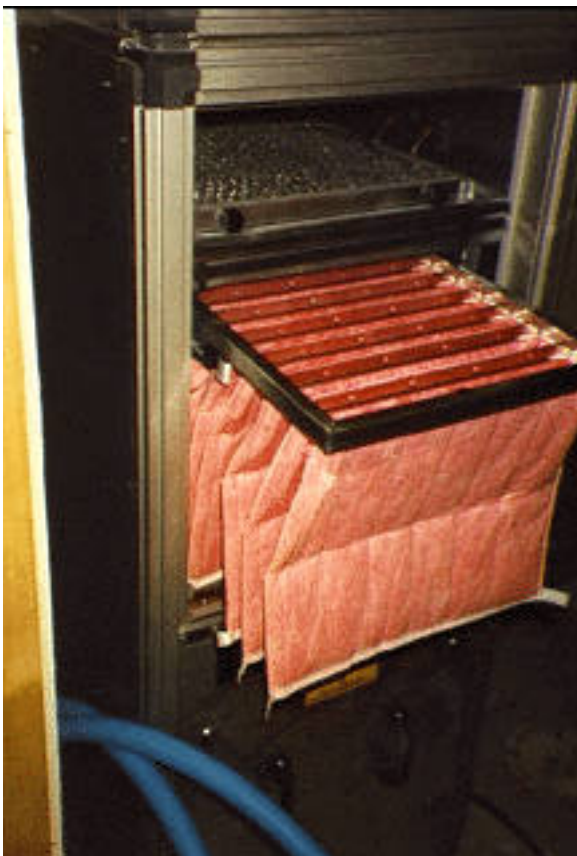
### Fine filter:

A bag filter with standard dimensions and big filter areas.

The fine filter, of which you settle the fineness, needs to be changed every second year.

A rapid connection system facilitates the change.

There are space enough for an alternative electrostatic filter.  
New filter models of Gore Tex which can be washed and recycled is developing.
